Manhole Inspection Summary

Manhole # S43Y1_008MH

Location Address: **910 E. Patapsco St.**

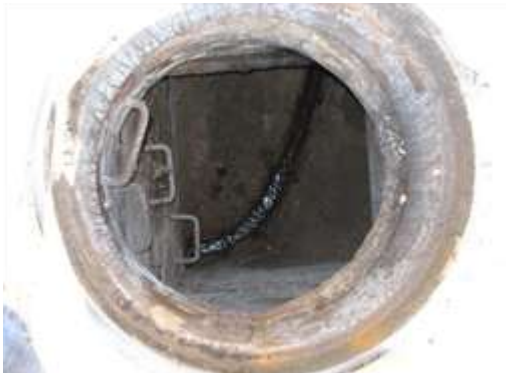
Top View

steps

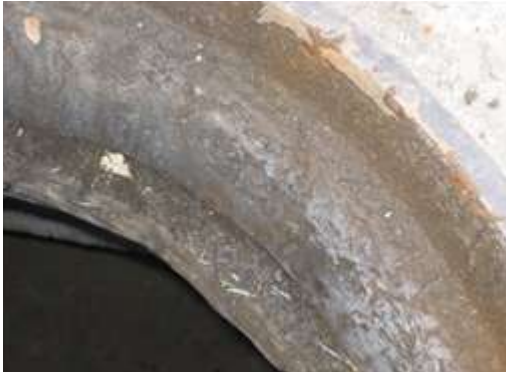
Defect 1

Frame Offset: **0.5** (in.) Condition: ☒ Sound ☐ Cracked ☐ Leaks

frame offset

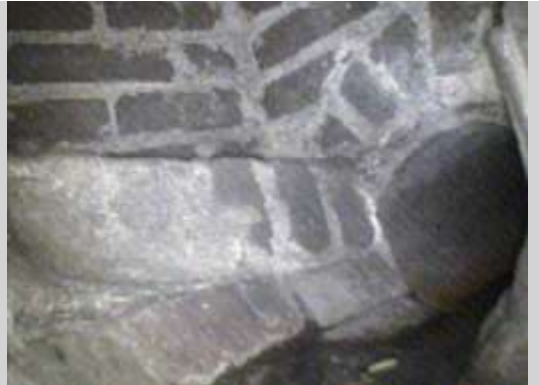
12 O'Clock Outflow

Comments **12 O'Clock pipe could not be measured due to its position in the manhole.**

8 in. Circular Service Sewer
Pipe Out @ 12 O'Clock

Pipe Height: **3.6** (in.) Direct (Angled)

Pipe Material: **Clay** ☐ Pipe Lined

Invert Depth: **1.00** (ft.) Flow Characteristics: **Slow**

Infiltration: **None** Pipe Seal Cond: **Sound**

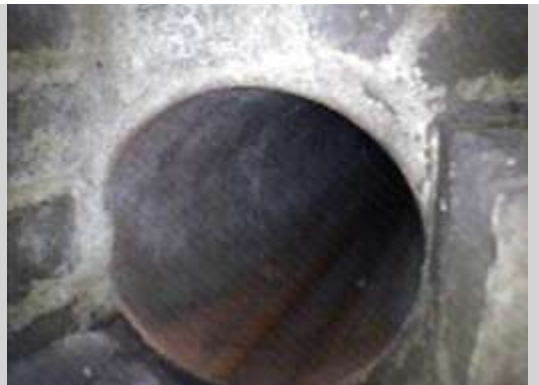
8 O'Clock Inflow

8 in. Circular Gravity Sewer
Pipe In @ 8 O'Clock

Pipe Height: **10.8** (in.) Rod and Bar (Angled)

Pipe Material: **Clay** ☐ Pipe Lined

Invert Depth: **8.80** (ft.) Flow Characteristics: **Slow**

Infiltration: **None** Pipe Seal Cond: **Sound**
